**Title: STAGE 1 ROAD SAFETY AUDIT**

**Proposed Strategic Housing Development, Northwood, Santry,  
Co. Dublin.**

**Client: Waterman Moylan**

**Report reference: 1363R01**

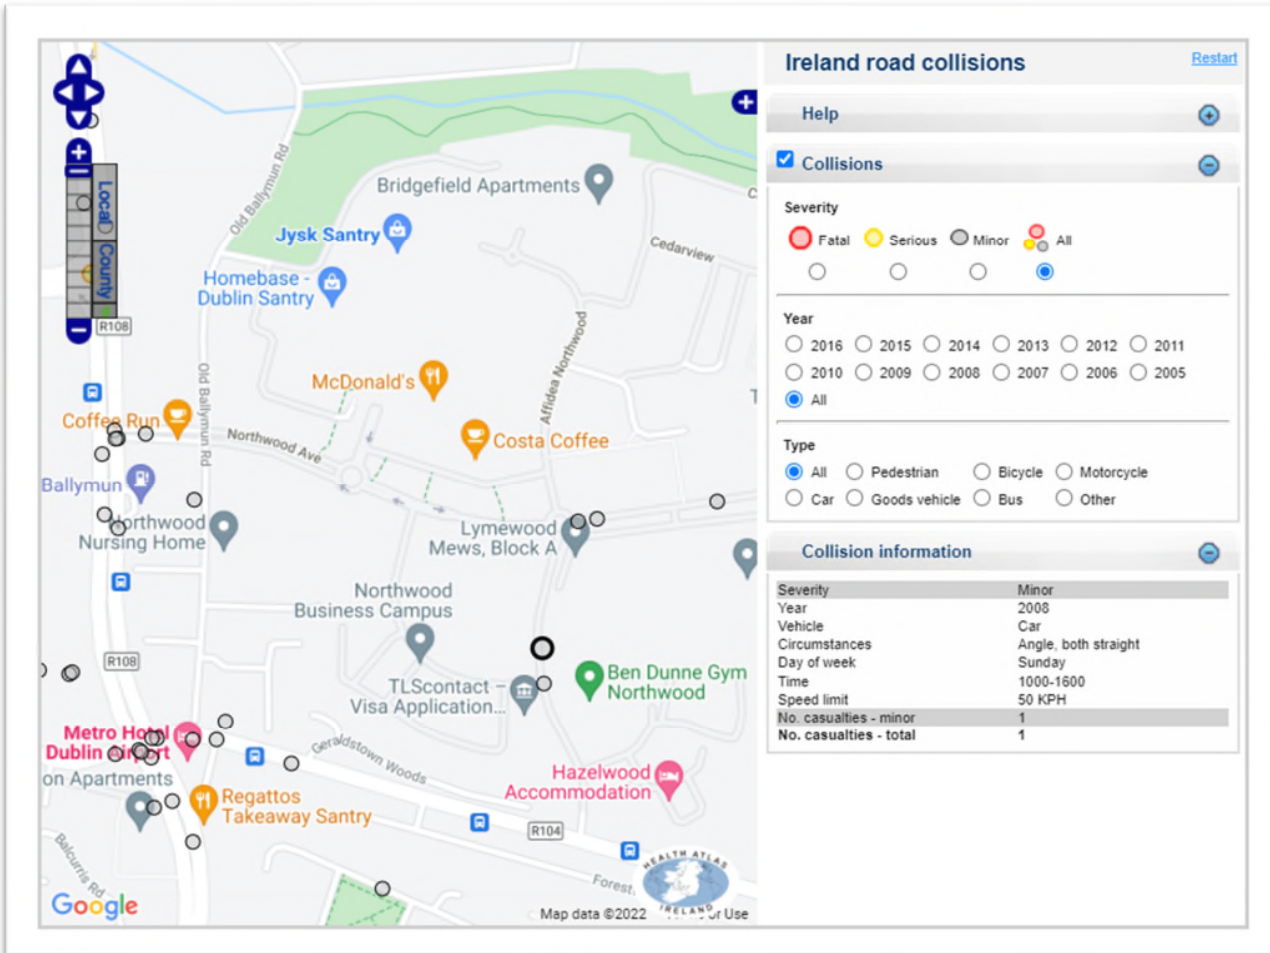
The Road Safety Authority’s website ([www.rsa.ie](http://www.rsa.ie)) shows that there were four recorded, minor injury collisions adjacent to the site in the years 2005 to 2016. Two collisions were at the Northwood Avenue roundabout and two along Northwood Road.

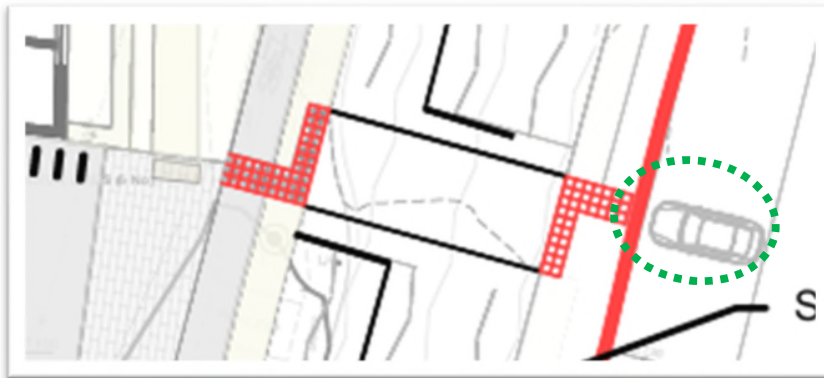
Drawing 21-033 P121 Rev -

It is proposed to relocate the signalised pedestrian crossing on Northwood Road north of the existing crossing and away from the proposed access to the development. The proposed location is at a perpendicular parking area. Drivers accessing/egressing from the parking spaces may collide with waiting pedestrians or the traffic signal infrastructure.

It is recommended that the crossing be located away from the parking area or that the parking be relocated away from the crossing point.

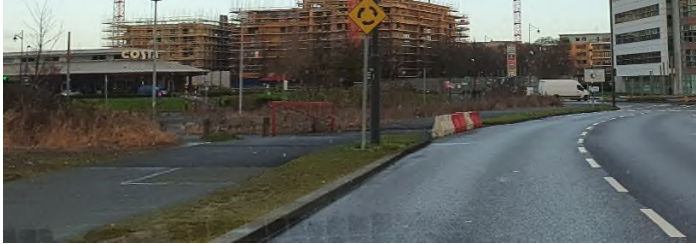
Drawing 21-033 P121 Rev -

There is an existing two way cycle track (albeit in disrepair) along Northwood Road and Northwood Avenue with a zebra crossing of Northwood Avenue connecting with the cycling network on the northern side of the road. Provision for cycling is not shown on the drawings and it is unclear if the zebra crossing is to be retained. A lack of dedicated facilities for cyclists will lead to sharing the carriageway with general traffic which will increase the risk and severity of collisions.

It is recommended that the cycle facilities be retained/upgraded.

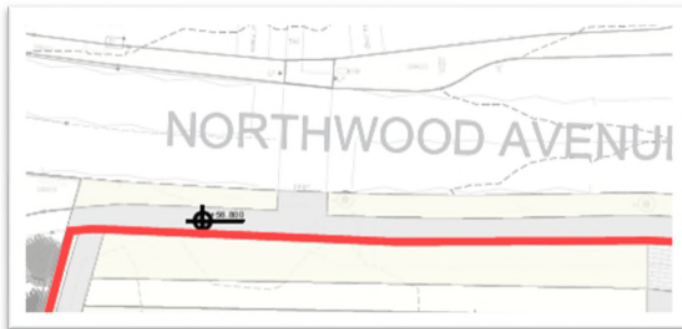
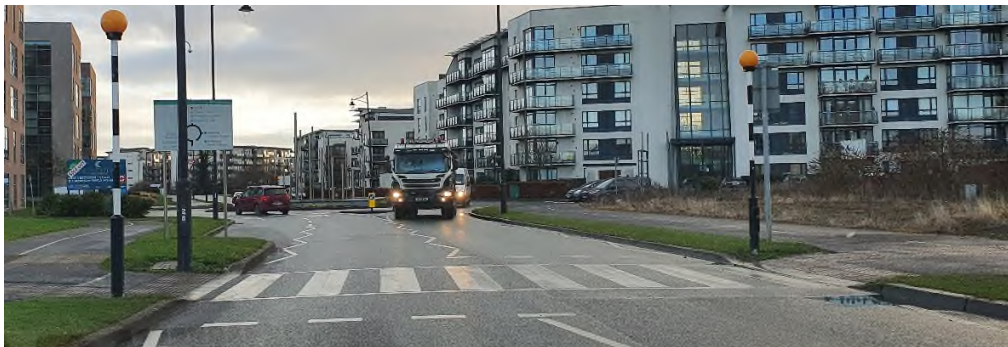
Drawing 21-033 P121 Rev -

The existing Zebra crossing on Northwood Avenue has L shaped tactile paving which is not shown on the drawings. This may lead to confusion as to where to cross for blind or partially sighted pedestrians.

It is recommended that the tactile paving be retained.

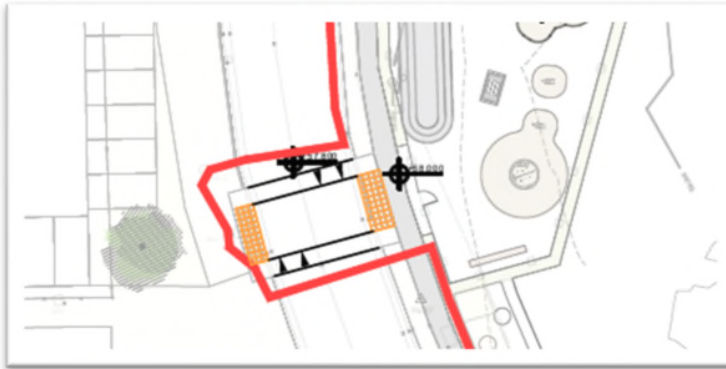
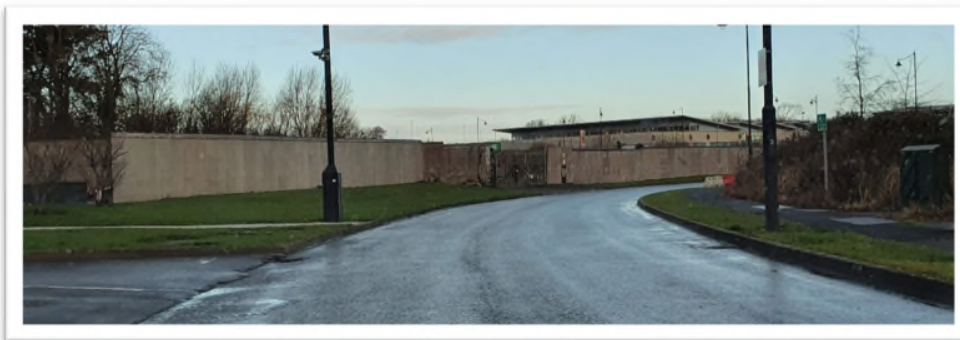
Drawing 21-033 P121 Rev -

The proposed uncontrolled pedestrian crossing of Northwood Crescent leads to an area currently without footpaths. It is unclear if there will be footpaths there in the future. If pedestrians travel on a grassed surface they may slip and fall.

It is recommended that the footpath be made continuous with the existing network.

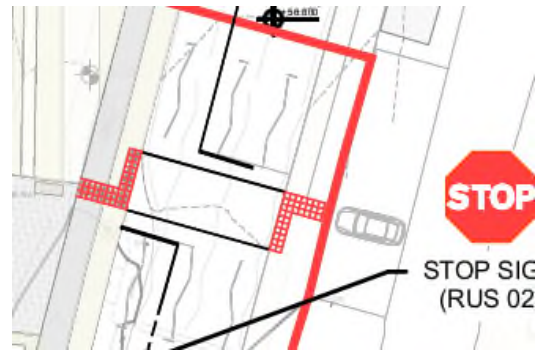
The centre line road markings at the relocated pedestrian crossing on Northwood Road appear to be drawn in the incorrect location. It is assumed that this is a draughting error.
